Unknown ('Cannon Site') Weymouth

Archaeological Services in Relation to Marine Protection
Undesignated Site Assessment

Undesignated Site Assessment

Prepared for:
Historic England

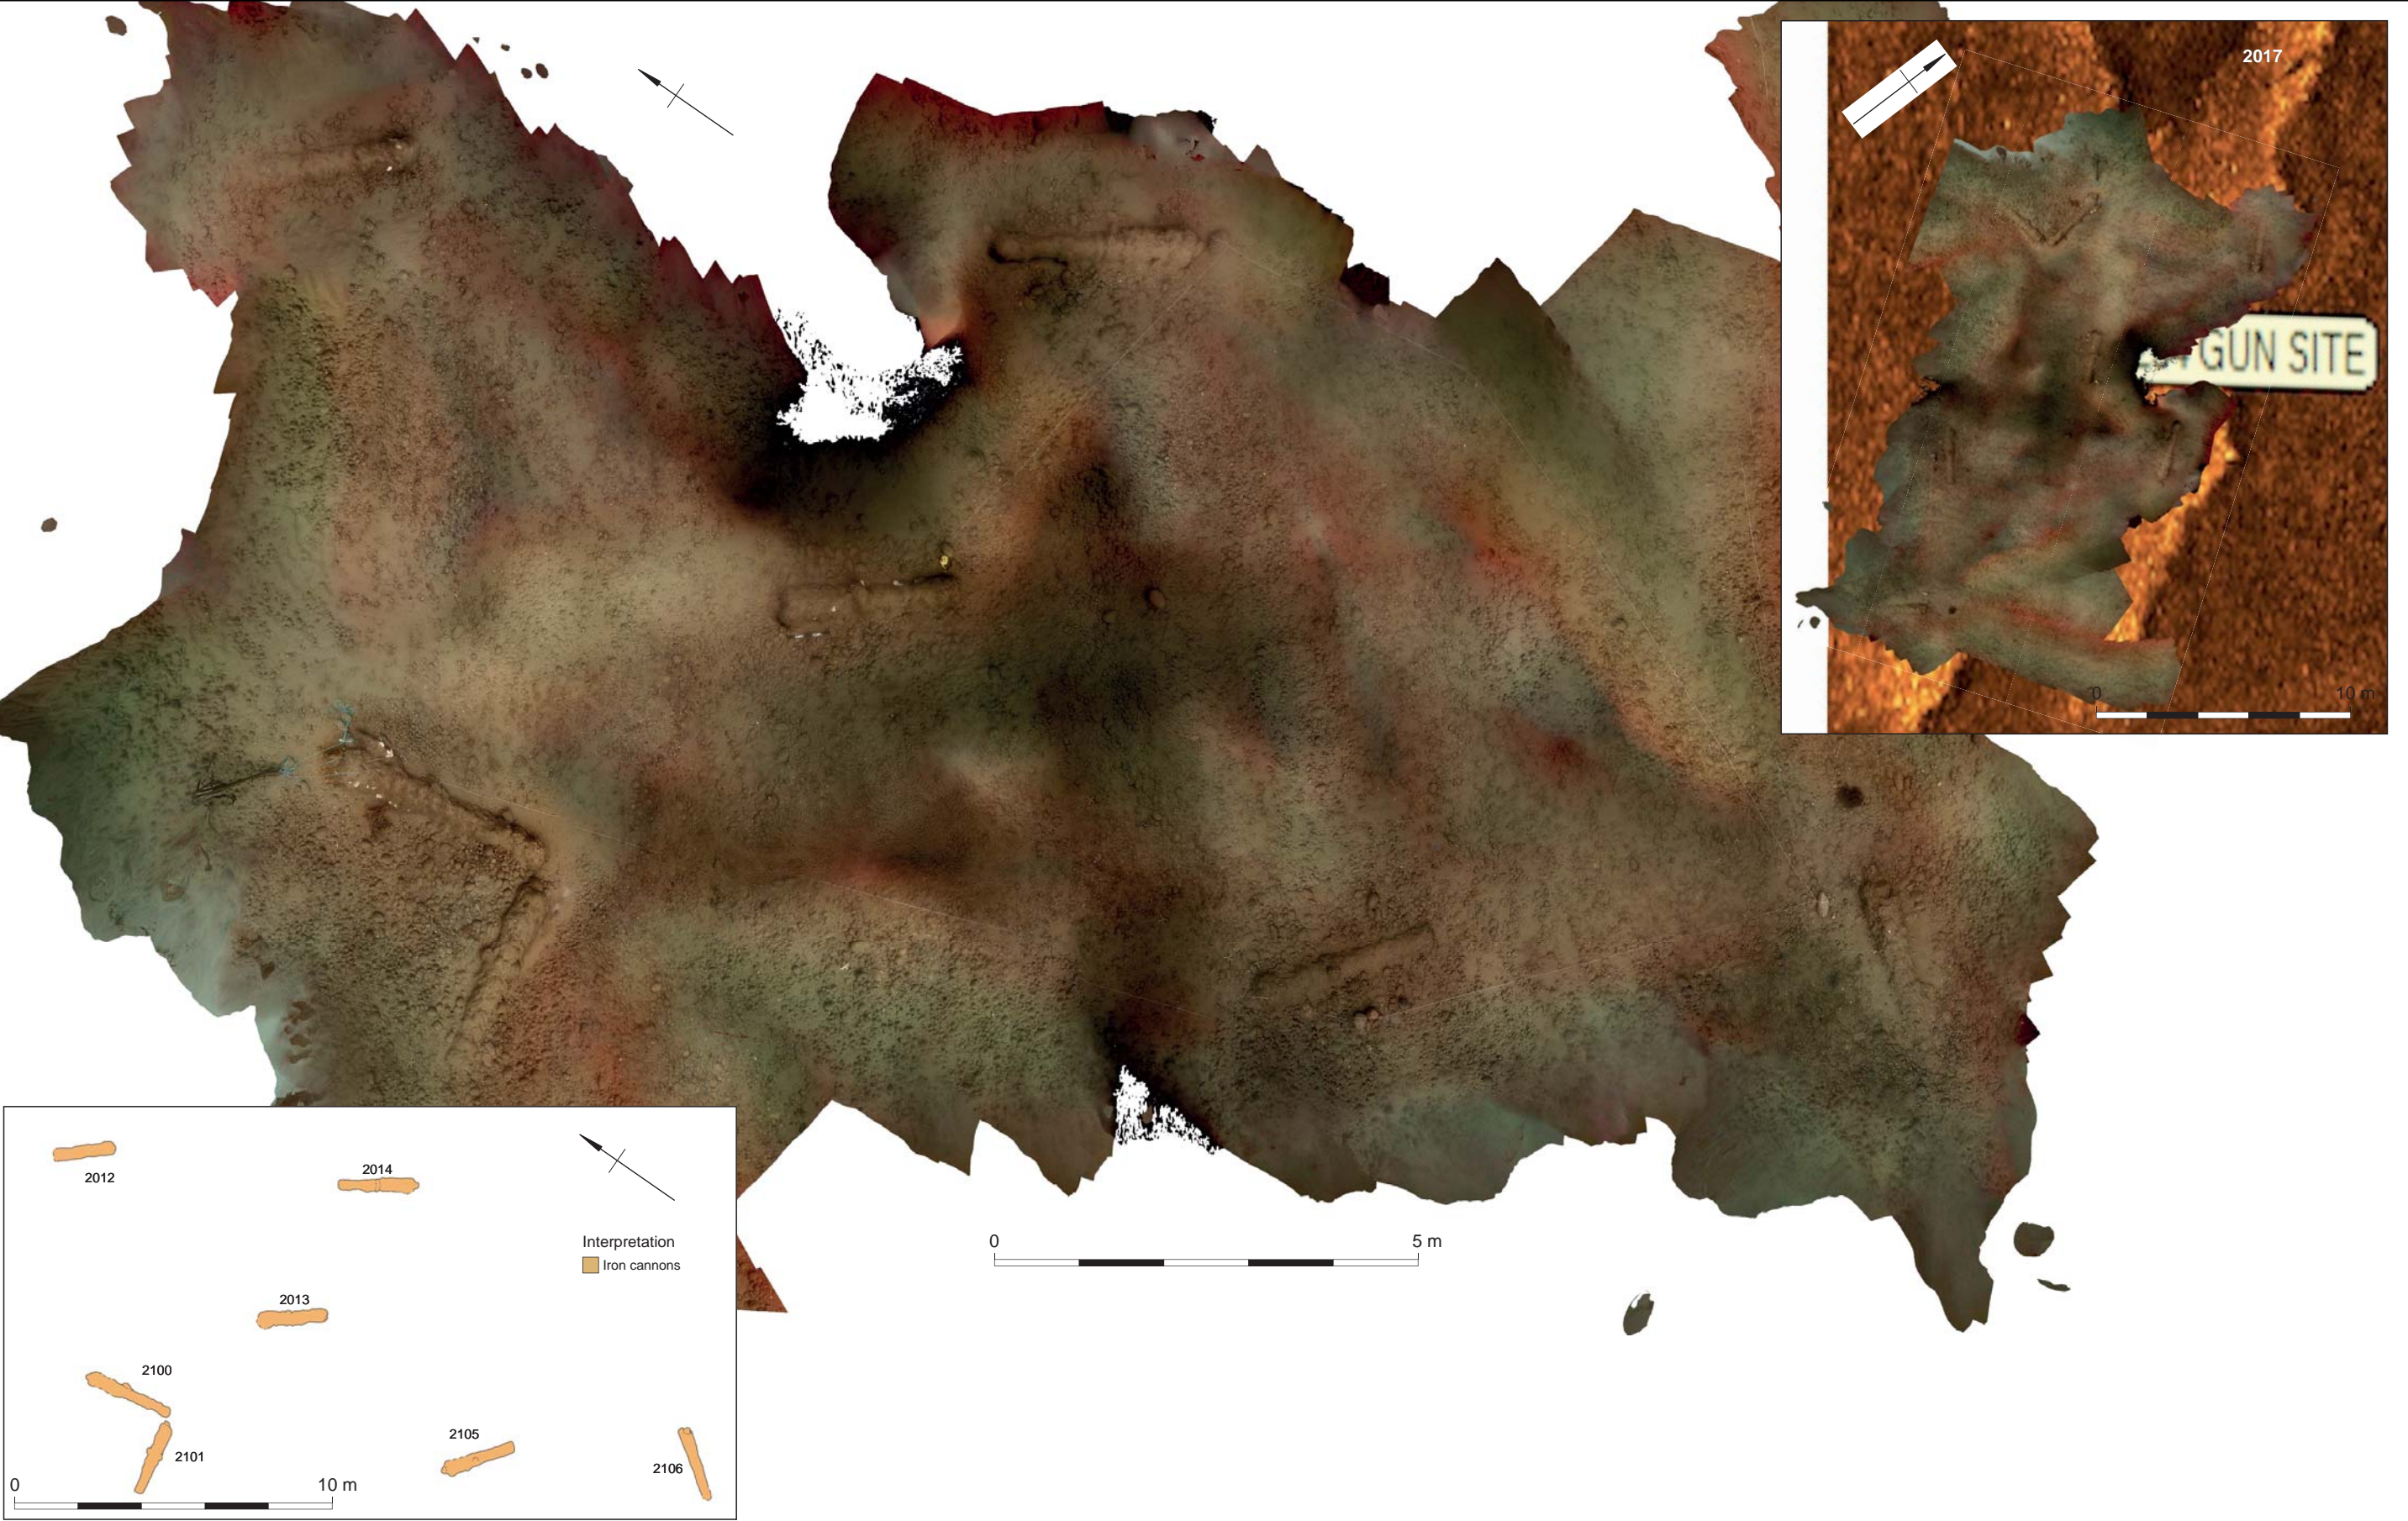
Detailed site plans have been created of Sites 1 and 2 using photogrammetry supported by measured survey and diver descriptions. These form part of the site archive which is being shared with the Shipwreck Project. Co-operation between the Shipwreck Project and Wessex Archaeology is regarded by both organisations as having been highly successful.

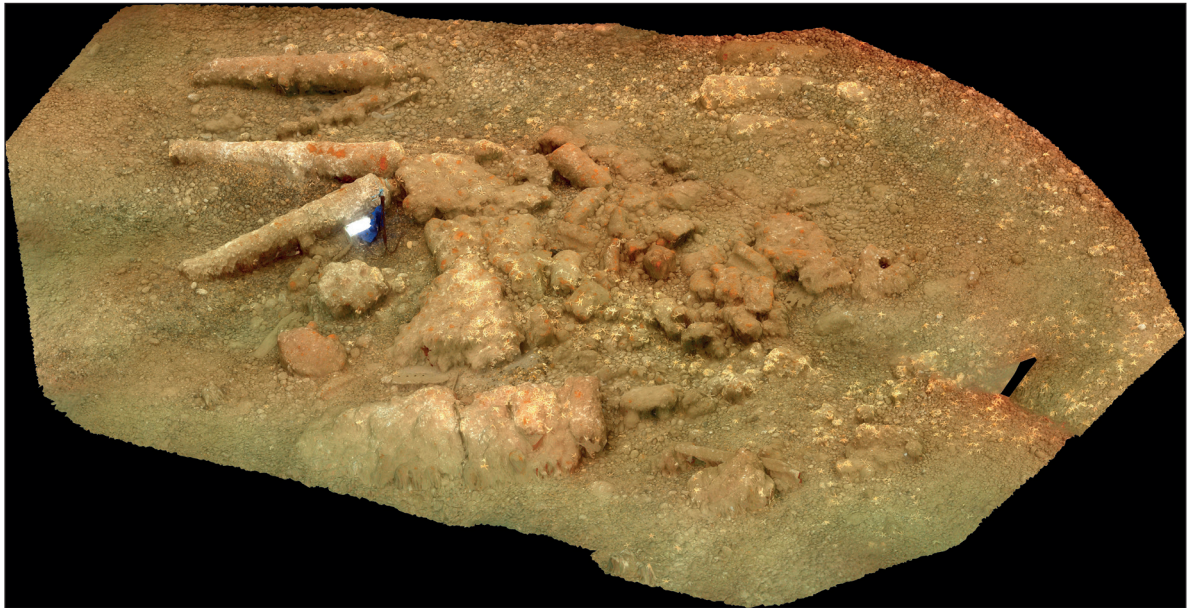
Plate 1: Site 1, looking inshore (2D orthophoto of photogrammetry model)

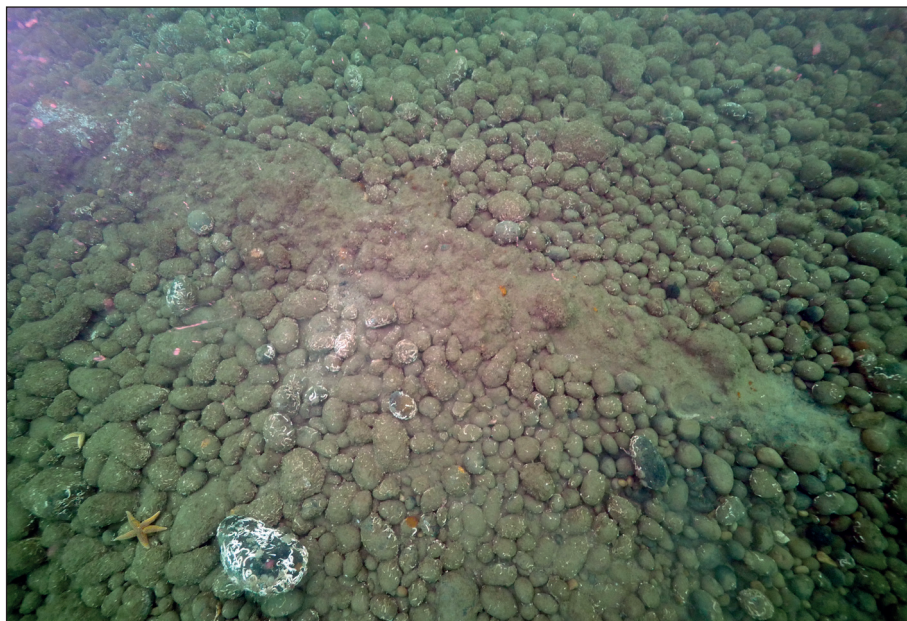
Plate 2: One of two guns found post-fieldwork inshore of Site 1 (© The Shipwreck Project)

- 5.1.4 The full extent of Site 1 is also uncertain and therefore further survey work is required, particularly on the inshore side where two additional cannon have recently been found. Due to the gravel and cobble seabed, probing is likely to be ineffective. For the same reason, the use of parametric or 3D CHIRP sonar is also unlikely to be effective. Subject to local conditions, a very detailed towed magnetometer or magnetometer/gradiometer may be worthwhile, as might a diver metal detector or gradiometer survey, provided that the latter has good positional control. Ultimately, however, establishing site extent both horizontally and vertically is likely to require some form of test pitting.

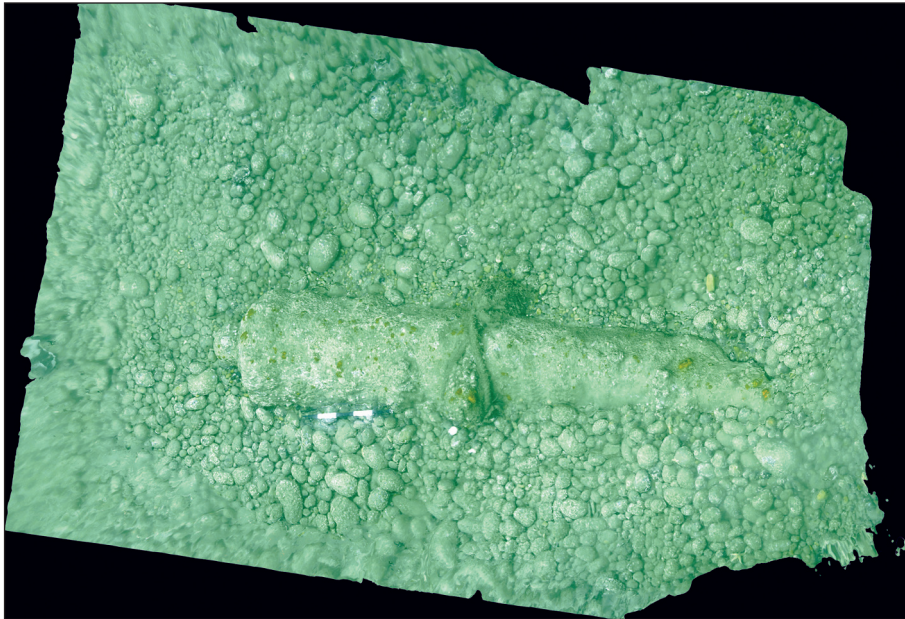
- 4.4.2 Discounting the outlying gun (**WA2007**) which lies approximately 11m to the west (**Plate 3**), the observed archaeological material covers an area of about 12m by 12m, roughly 144 square metres. Seabed within the site is gravel with occasional cobbles. Depth established from multibeam survey is approximately 11m below Lowest Astronomical Tide (LAT).

- 4.4.5 Only one of the guns, **WA2002**, is undamaged. The remainder have damage to their muzzles, most noticeably **WA2003** which has lost its muzzle. **WA2007** was observed to have a modern rope stop twisted around both trunnions (**Plate 3**). This may or may not represent an attempt to move it.

Plate 3: Cannon 2007 (2D orthophoto of photogrammetry model)

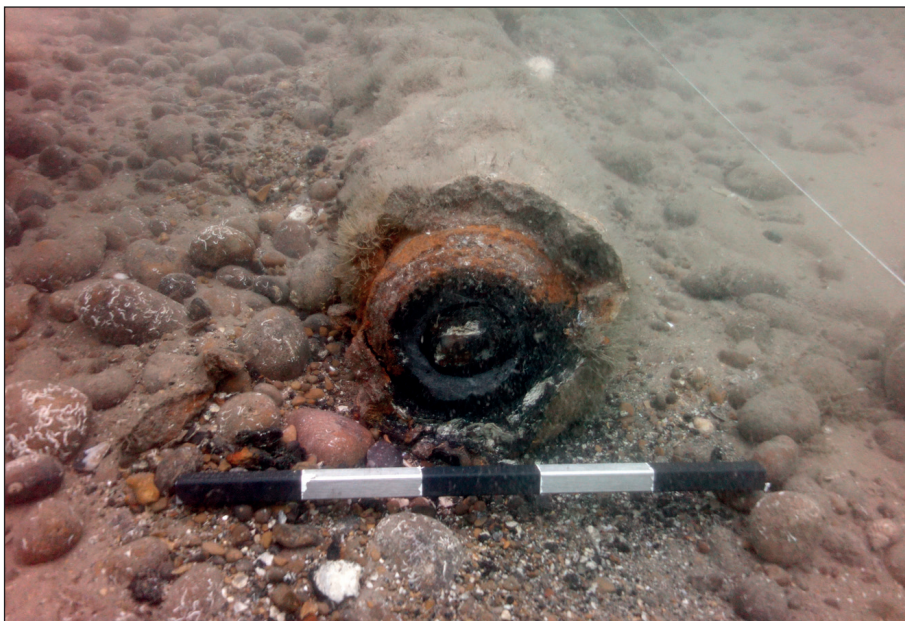
- 4.4.18 Concretion appears to have been recently and deliberately removed from the muzzles of **WA2103** and **WA2106**, exposing the bare metal surface. In both cases the metal is corroding and concretion is starting to re-establish itself. **WA2106** appears to have muzzle rings and a swell. **WA2103** was subject to close visual inspection after the removal of a

Plate 4: Gun 2103, muzzle

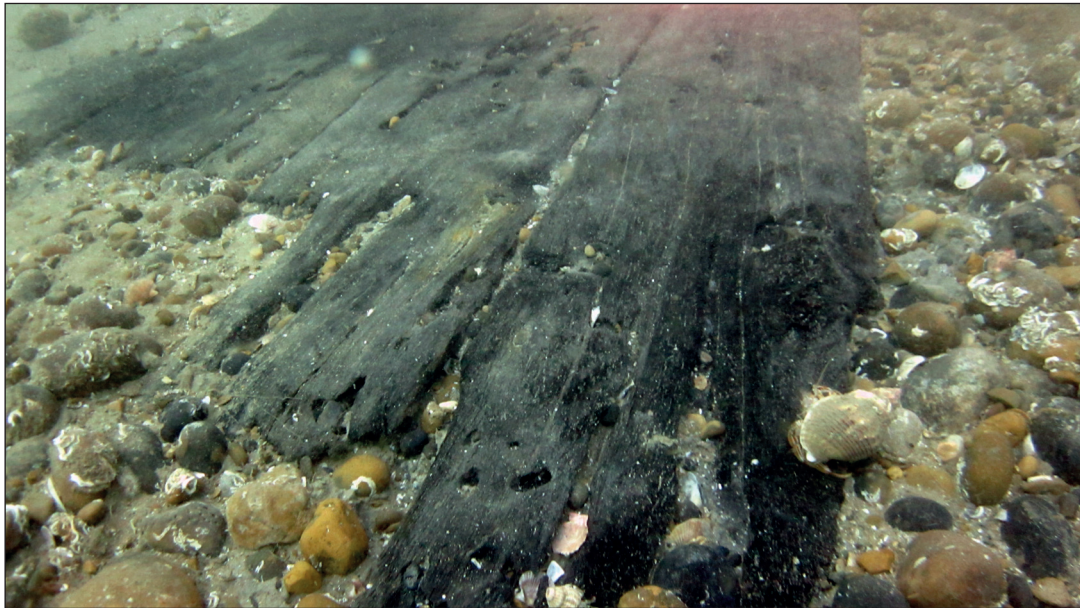
Site 3, further to the south-east is a small section of wooden ship hull, with carvel planking, probably oak. It is not known whether it is associated with either Site 1 or 2. Investigation here is at a very early stage.

Plate 5: Ship structure, Site 3 (© The Shipwreck Project)

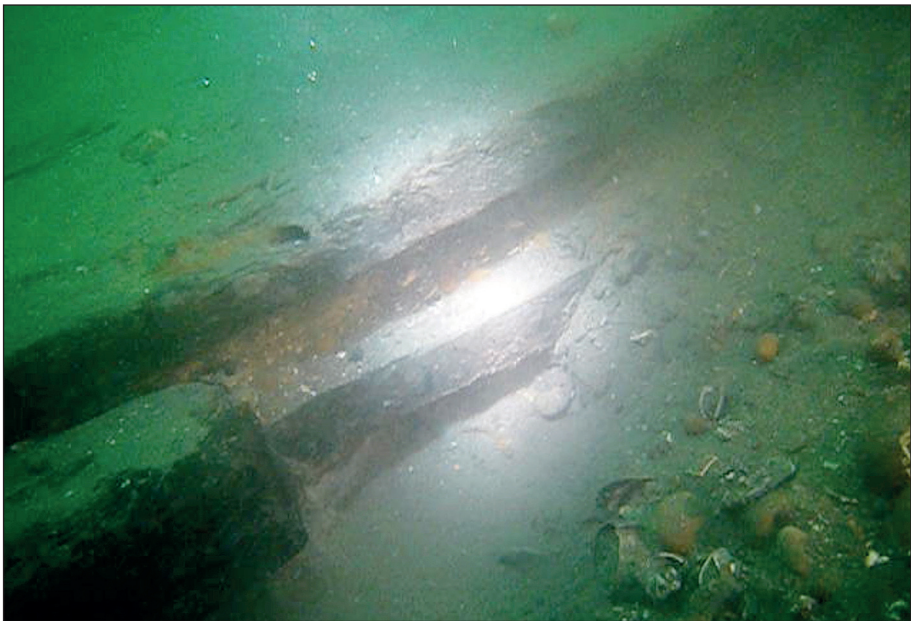
- 4.4.23 When discovered the Shipwreck Project dug a small hole at the side of the structure. They report having found what appeared to be a frame below the planking and below that a further layer of planking, which may have a small opening cut into it (**Plate 6**; Grahame Knott, pers. comm.).

Plate 6: Ship structure, Site 3 (side view) © The Shipwreck Project
